**Flood Control Project Maintenance
Levee Inspections**
LMA District Cover Sheet
Spring 2010 Levee Inspection Results

Reclamation District No. 0765 Glide

Waterway			Bank	Unit Miles
Unit No. 01 Sacramento River			Right	1.74
	Spring (March - May)	Summer (June - August)	(September - November) Fall	Winter (December - February)
Unit Maintenance Rating (Fall Only)				
Date of Inspection	3/17/2010 - 3/17/2010			
DWR Inspector	Richard Willoughby			
Accompanied By	Dave Chestnut RD765

Levee Inspection Report By Mile - Spring 2010

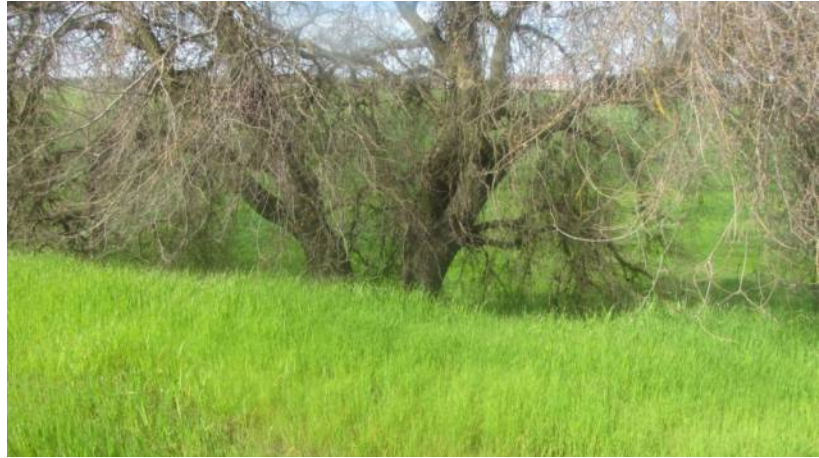
Levee Mile Report Line	5
Start Levee Mile	0.12
End Levee Mile	0.19
Location	Land Side
Category	Earthen Levee
Item	Trim / Thin Trees

Looking west at trees on landside toe.

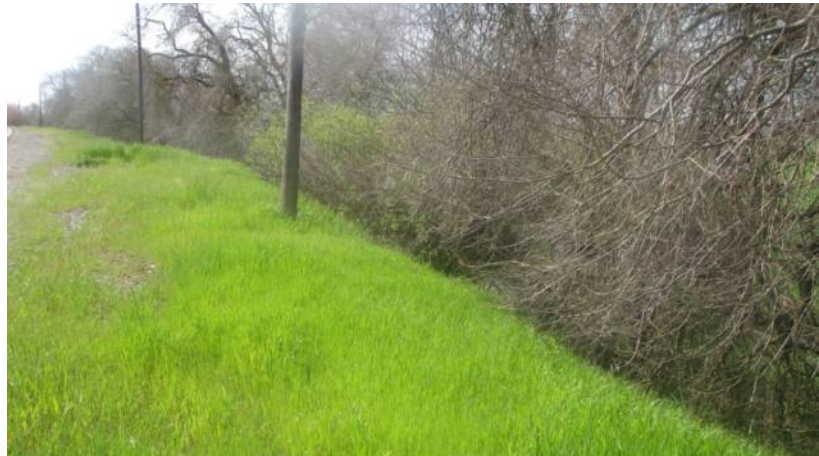
Levee Mile Report Line	5
Start Levee Mile	0.12
End Levee Mile	0.19
Location	Land Side
Category	Earthen Levee
Item	Trim / Thin Trees

Looking downstream (south) at trees on landside slope & toe.

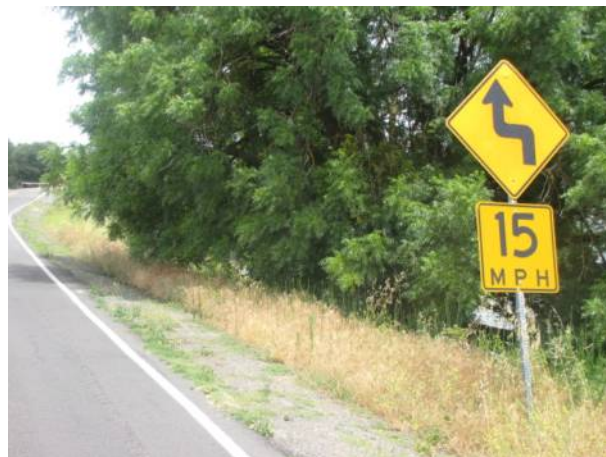
Levee Mile Report Line	8
Start Levee Mile	0.25
End Levee Mile	0.28
Location	Water Side
Category	Earthen Levee
Item	Trim / Thin Trees

Looking northeast at overgrown trees on waterside slope.

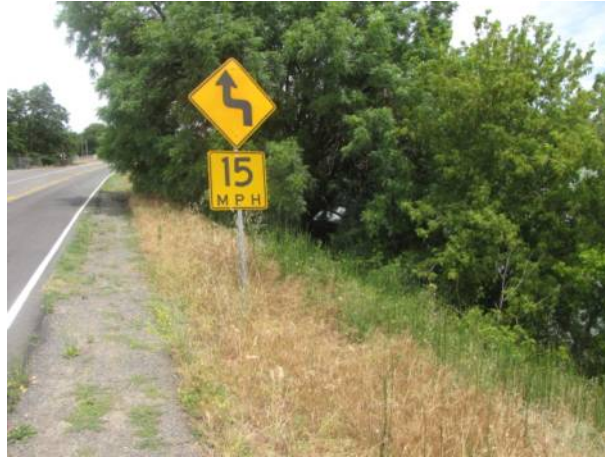
Levee Mile Report Line	8
Start Levee Mile	0.25
End Levee Mile	0.28
Location	Water Side
Category	Earthen Levee
Item	Trim / Thin Trees

Looking north at overgrown trees on waterside slope.

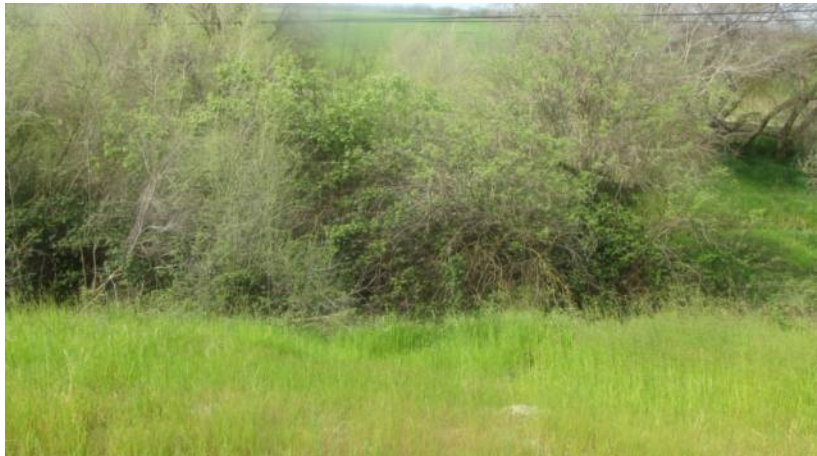
Levee Mile Report Line	13
Start Levee Mile	0.48
End Levee Mile	0.50
Location	Land Side
Category	Earthen Levee
Item	Vegetation

Looking northwest at trees on landside toe.

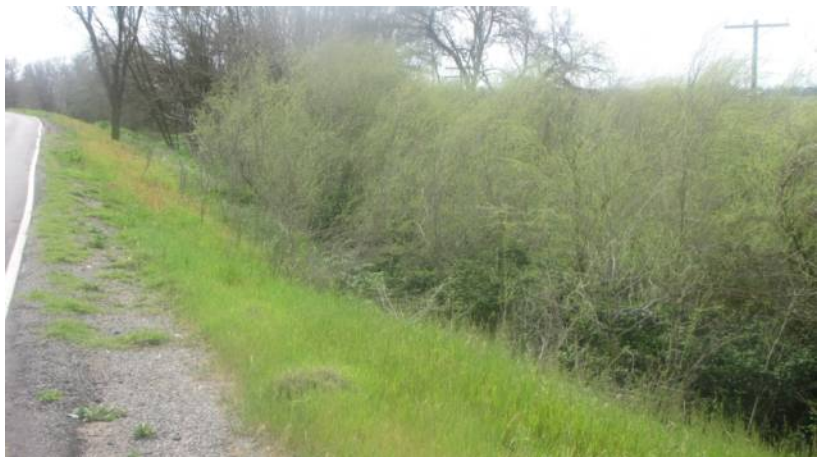
Levee Mile Report Line	13
Start Levee Mile	0.48
End Levee Mile	0.50
Location	Land Side
Category	Earthen Levee
Item	Vegetation

Looking downstream (south) at trees on landside slope & toe.

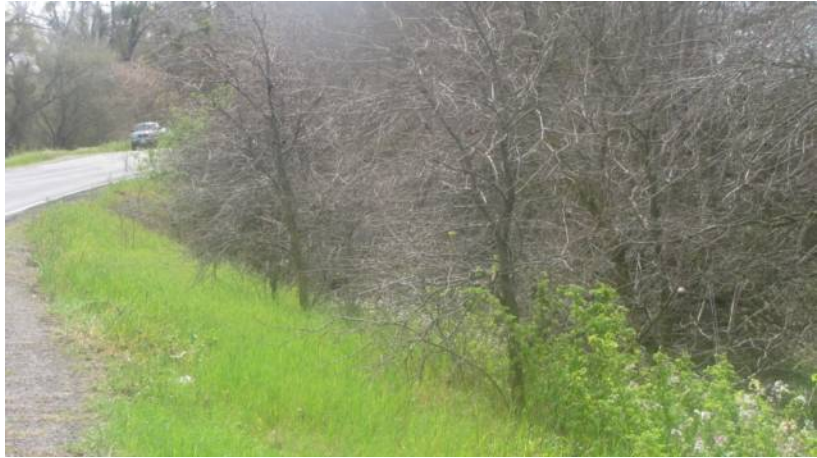
Levee Mile Report Line	23
Start Levee Mile	0.87
End Levee Mile	1.03
Location	Land Side
Category	Earthen Levee
Item	Trim / Thin Trees

Looking downstream (south) at trees on landside slope & toe.

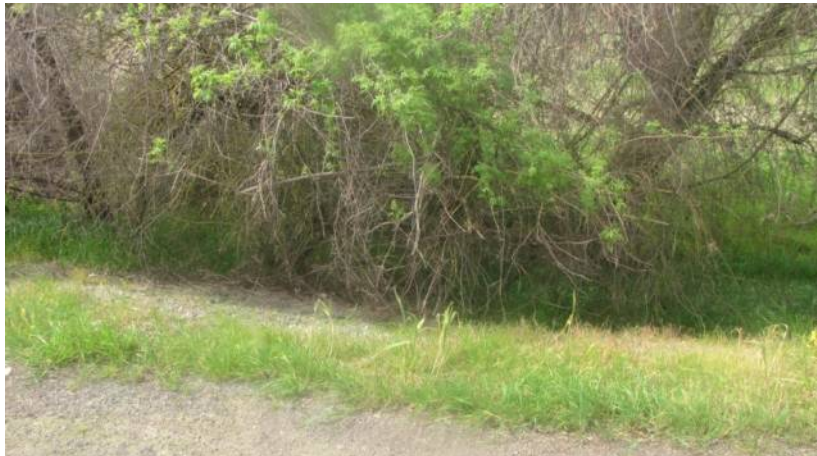
Levee Mile Report Line	23
Start Levee Mile	0.87
End Levee Mile	1.03
Location	Land Side
Category	Earthen Levee
Item	Trim / Thin Trees

Looking west at trees and vines on landside toe.

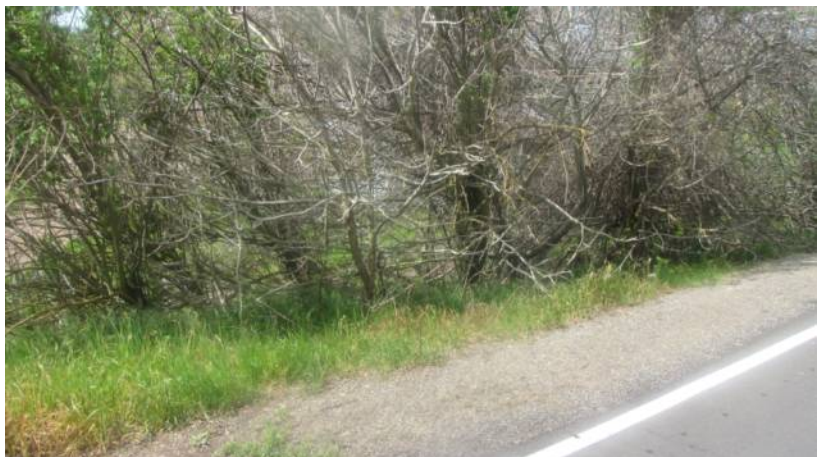
Levee Mile Report Line	23
Start Levee Mile	0.87
End Levee Mile	1.03
Location	Land Side
Category	Earthen Levee
Item	Trim / Thin Trees

Looking upstream (northwest) at trees on landside slope & toe.

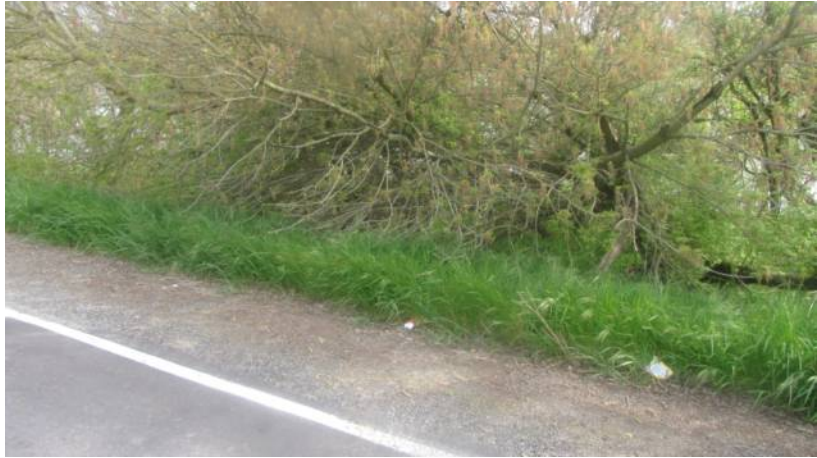
Levee Mile Report Line	25
Start Levee Mile	0.99
End Levee Mile	1.05
Location	Water Side
Category	Earthen Levee
Item	Trim / Thin Trees

Looking northeast at trees on waterside slope.

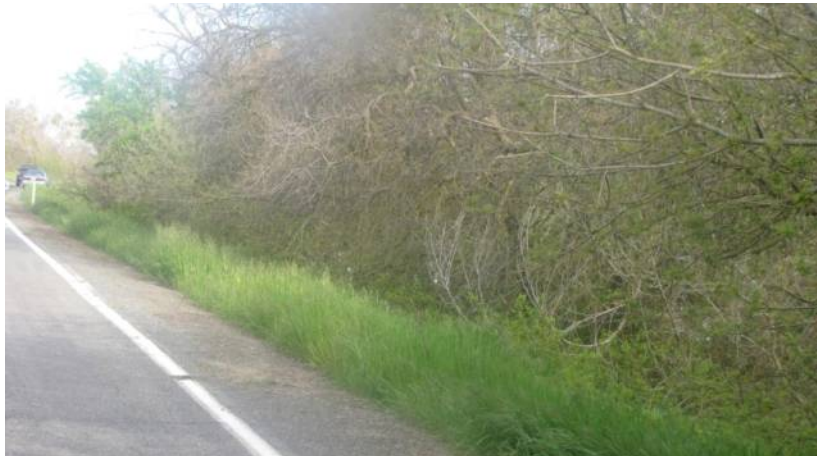
Levee Mile Report Line	25
Start Levee Mile	0.99
End Levee Mile	1.05
Location	Water Side
Category	Earthen Levee
Item	Trim / Thin Trees

Looking upstream (north) at trees on waterside slope.

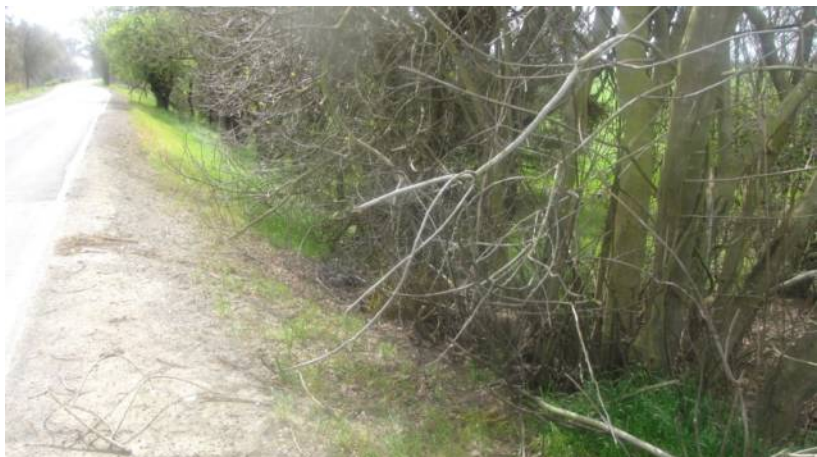
Levee Mile Report Line	26
Start Levee Mile	1.08
End Levee Mile	1.08
Location	Land Side
Category	Earthen Levee
Item	Trim / Thin Trees

Looking downstream (south) at trees on landside slope & toe.

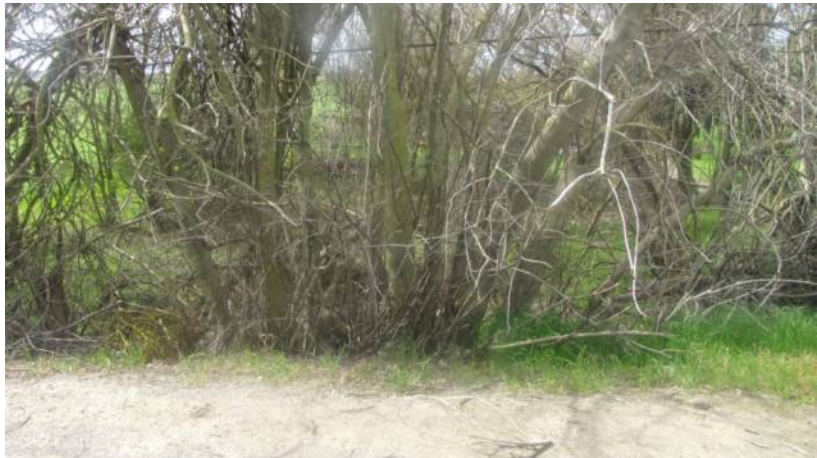
Levee Mile Report Line	26
Start Levee Mile	1.08
End Levee Mile	1.08
Location	Land Side
Category	Earthen Levee
Item	Trim / Thin Trees

Looking west at trees on landside slope & toe.

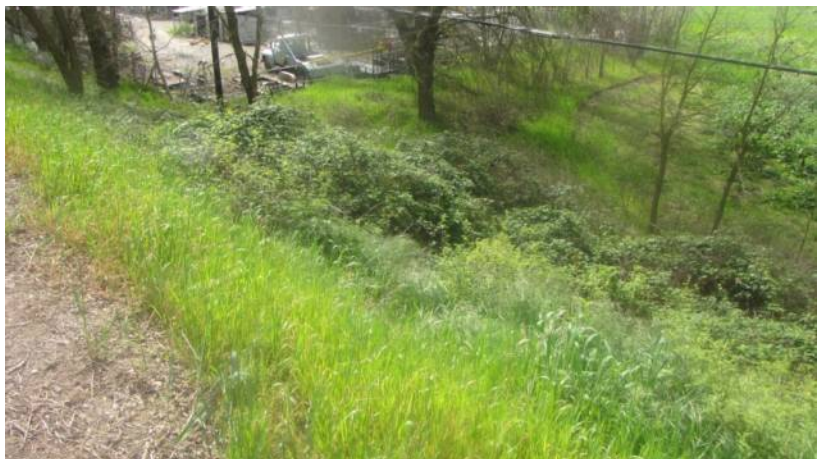
Levee Mile Report Line	29
Start Levee Mile	1.15
End Levee Mile	1.15
Location	Land Side
Category	Earthen Levee
Item	Vegetation

Looking downstream (southwest) at wild roses on landside slope & toe.

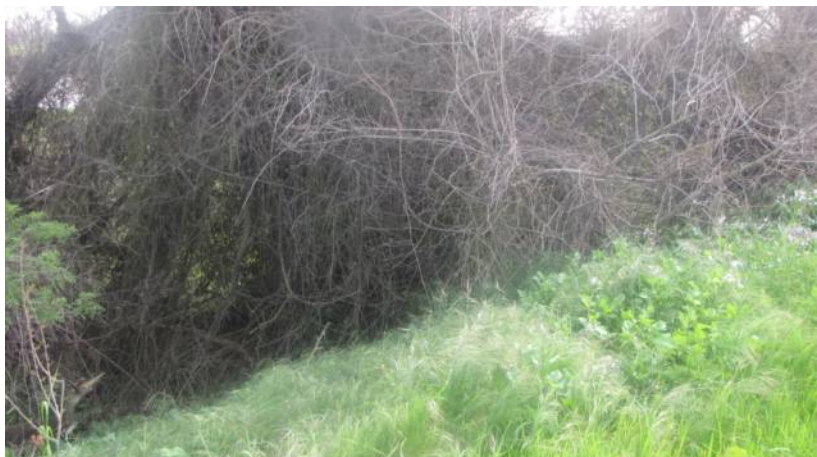
Levee Mile Report Line	32
Start Levee Mile	1.36
End Levee Mile	1.36
Location	Water Side
Category	Earthen Levee
Item	Trim / Thin Trees

Looking southeast (downstream) at trees on waterside slope.

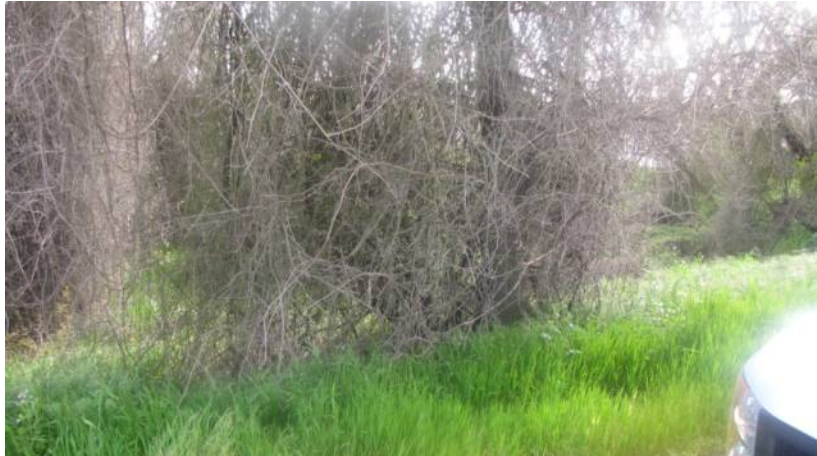
Levee Mile Report Line	33
Start Levee Mile	1.39
End Levee Mile	1.39
Location	Water Side
Category	Earthen Levee
Item	Trim / Thin Trees

Looking southeast (downstream) at tree on waterside slope

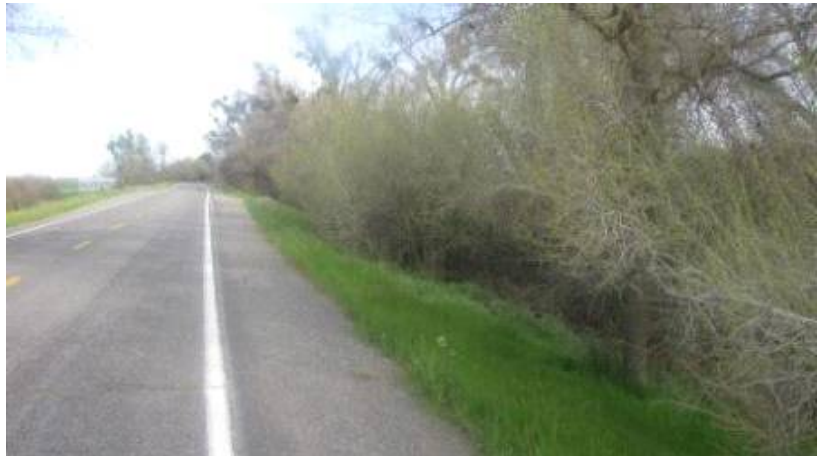
Levee Mile Report Line	35
Start Levee Mile	1.44
End Levee Mile	1.47
Location	Water Side
Category	Earthen Levee
Item	Trim / Thin Trees

Looking upstream (north) at trees on waterside slope.

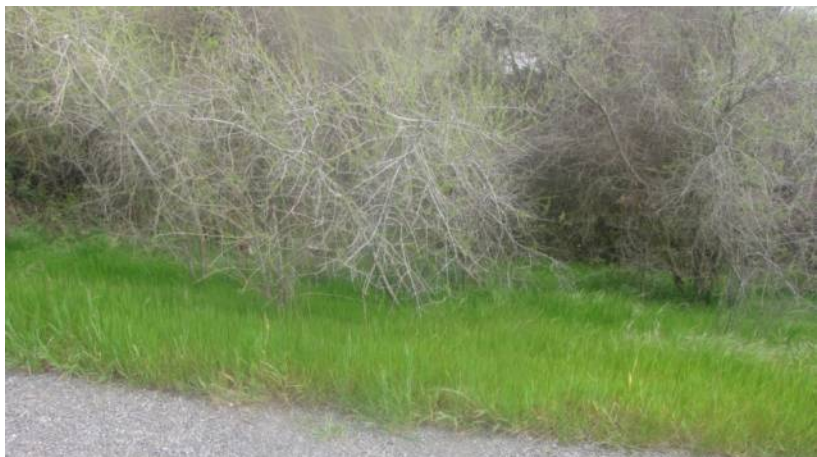
Levee Mile Report Line	35
Start Levee Mile	1.44
End Levee Mile	1.47
Location	Water Side
Category	Earthen Levee
Item	Trim / Thin Trees

Looking east at trees on waterside slope.

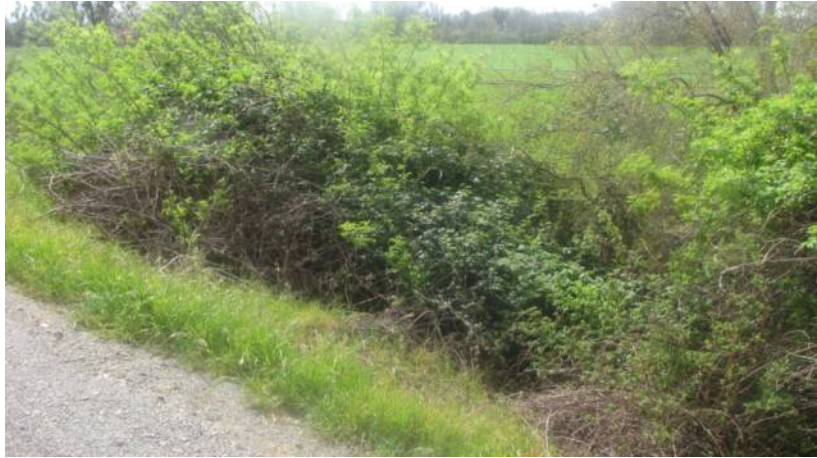
Levee Mile Report Line	39
Start Levee Mile	1.54
End Levee Mile	1.54
Location	Land Side
Category	Earthen Levee
Item	Vegetation

Looking downstream (southwest) at trees, vines & wildroses on landside slope & toe.

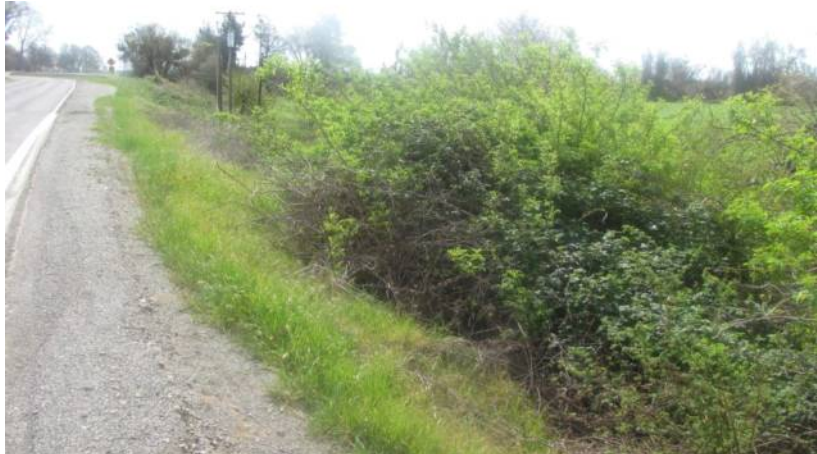
Levee Mile Report Line	39
Start Levee Mile	1.54
End Levee Mile	1.54
Location	Land Side
Category	Earthen Levee
Item	Vegetation

Looking downstream (south) at trees, vines & wildroses on landside slope & toe.

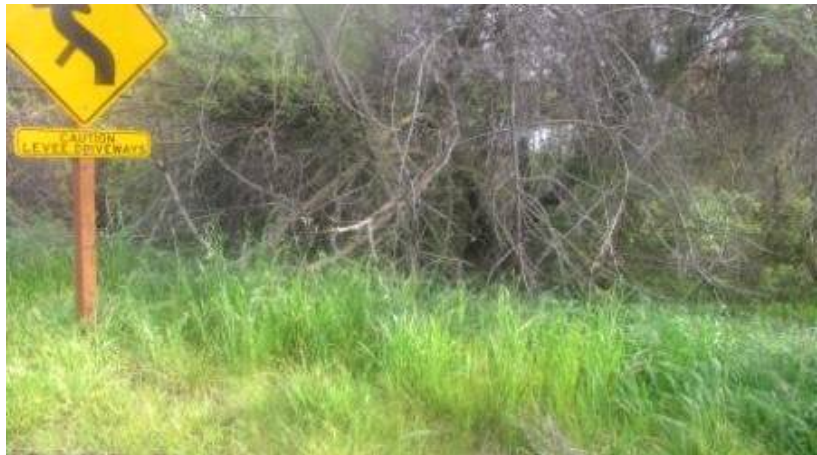
Levee Mile Report Line	40
Start Levee Mile	1.60
End Levee Mile	1.67
Location	Water Side
Category	Earthen Levee
Item	Trim / Thin Trees

Looking east at trees on waterside slope.

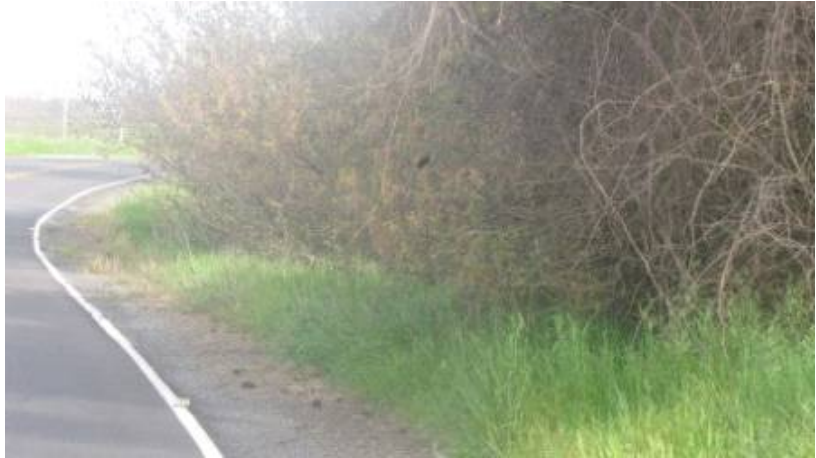
Levee Mile Report Line	40
Start Levee Mile	1.60
End Levee Mile	1.67
Location	Water Side
Category	Earthen Levee
Item	Trim / Thin Trees
Looking upstream (north) at trees on waterside slope.	
richard_s_20100318_147.jpg

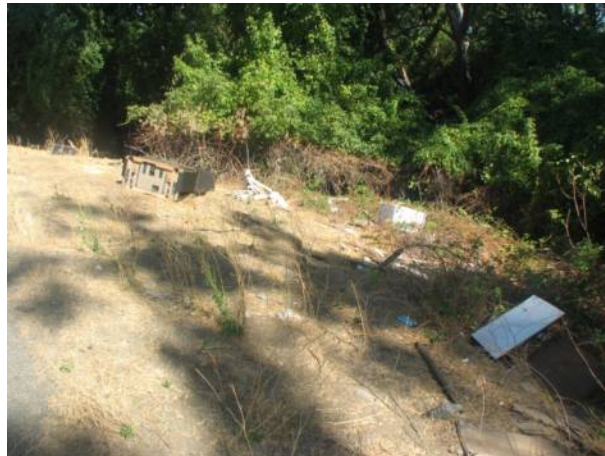
Levee Mile Report Line	42
Start Levee Mile	1.69
End Levee Mile	1.69
Location	Water Side
Category	Earthen Levee
Item	Encroachments
Looking upstream at garbage on waterside slope.	
richard_s_20100316_094.jpg

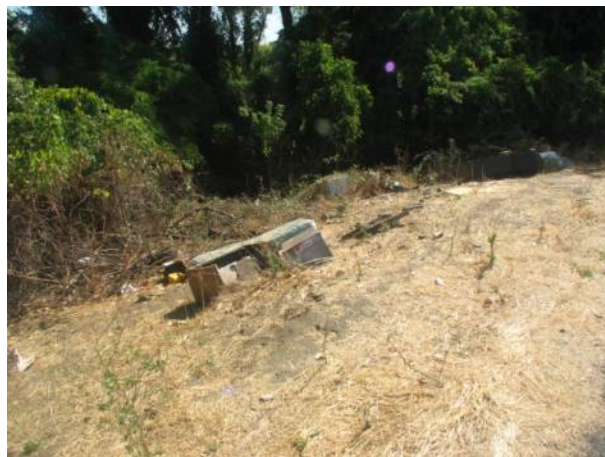
Levee Mile Report Line	42
Start Levee Mile	1.69
End Levee Mile	1.69
Location	Water Side
Category	Earthen Levee
Item	Encroachments
Looking downstream at garbage on waterside slope.	
richard_s_20100316_095.jpg

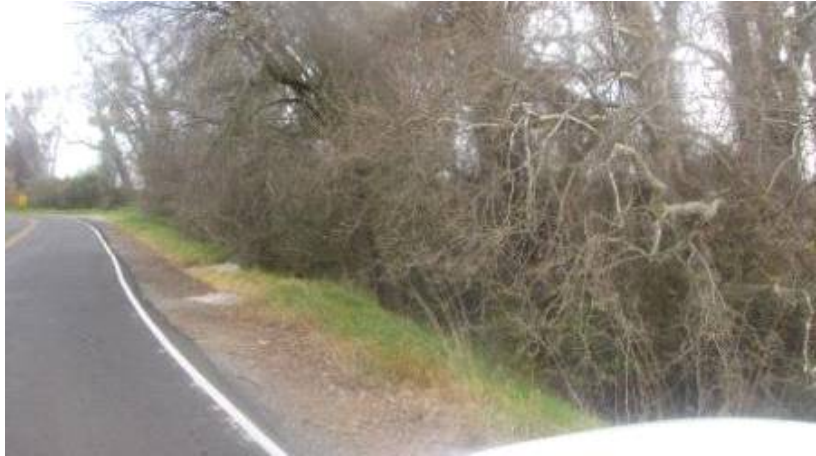
Levee Mile Report Line	43
Start Levee Mile	1.70
End Levee Mile	1.73
Location	Water Side
Category	Earthen Levee
Item	Trim / Thin Trees
Looking upstream (north) at trees on waterside slope.	
richard_s_20100318_144.jpg

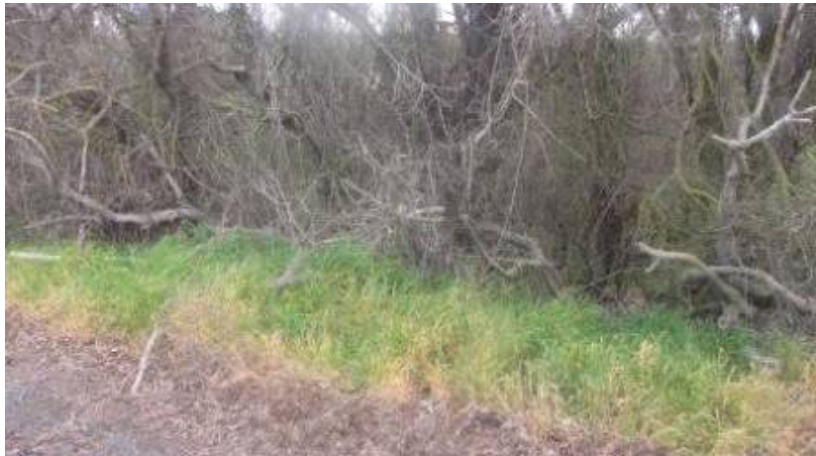
Levee Mile Report Line	43
Start Levee Mile	1.70
End Levee Mile	1.73
Location	Water Side
Category	Earthen Levee
Item	Trim / Thin Trees
Looking east at trees on waterside slope.	
richard_s_20100318_145.jpg
